Engineering for Rehabilitation of Historic Metal Truss Bridges

By Frank J. Hatfield, P.E.
Professor Emeritus, Civil and
Environmental Engineering
Michigan State University
East Lansing, Michigan

Editor's Note: An earlier version of this paper was presented at the 7th Historic Bridges Conference in Cleveland, Ohio, in September 2001, and was published in the proceedings of that conference.

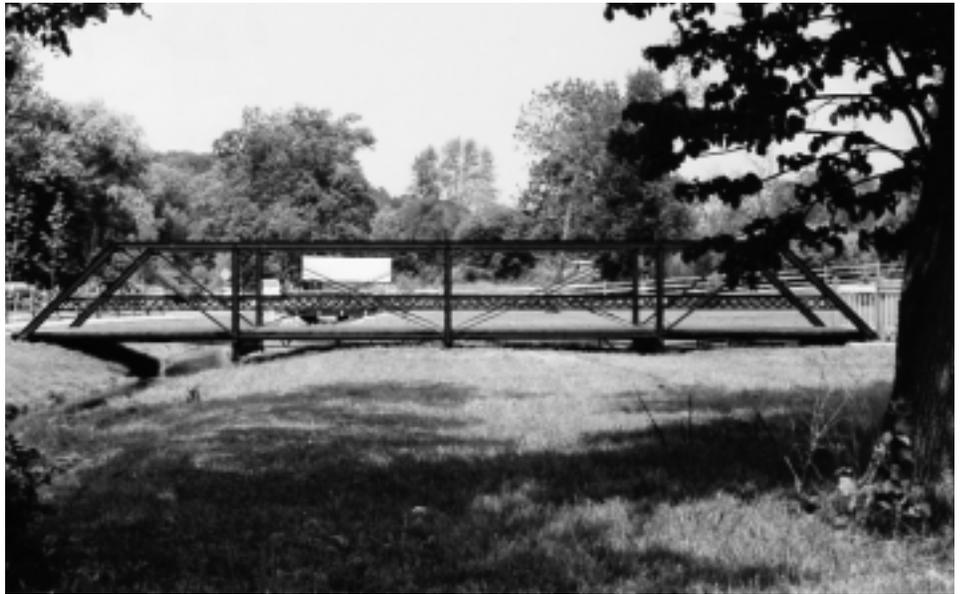
Figure 1. The rehabilitated 133rd Avenue bridge, installed at the Calhoun County Historic Bridge Park.

- 133rd Avenue bridge (Figure 1), a pin-connected half-hip Pratt pony truss spanning 64 ft. (19.5 m), erected in 1897 by the Michigan Bridge Company to cross the Rabbit River in Allegan County, Michigan.
- Twenty Mile Road bridge (Figure 2), a 70 ft. (21 m) long riveted Pratt pony truss that spanned the St. Joseph River in Calhoun County. Physical features hint that this bridge was designed for railway service. The builder has not been identified and several sources date construction to the early twentieth century.

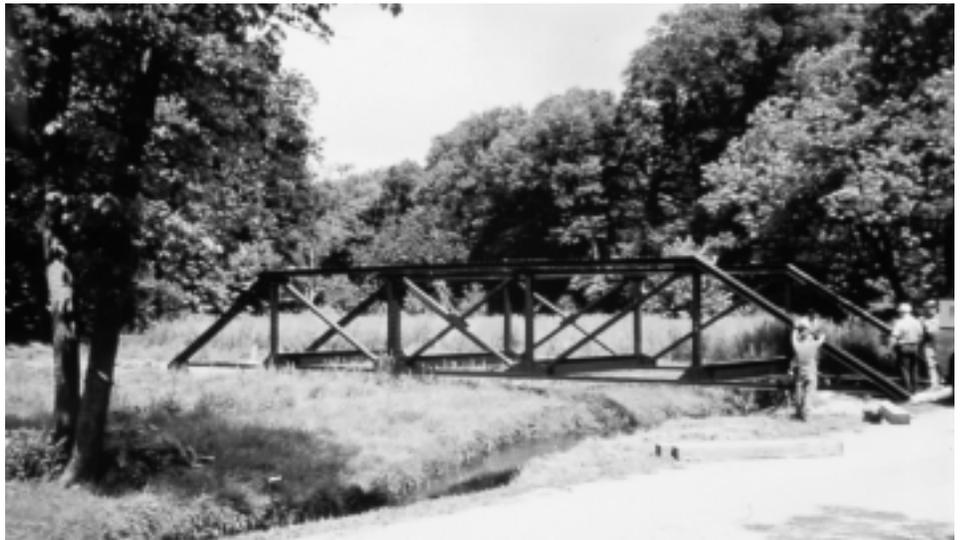
Figure 2. The rehabilitated Twenty Mile Road bridge, shown in its new position at the Historic Bridge Park.

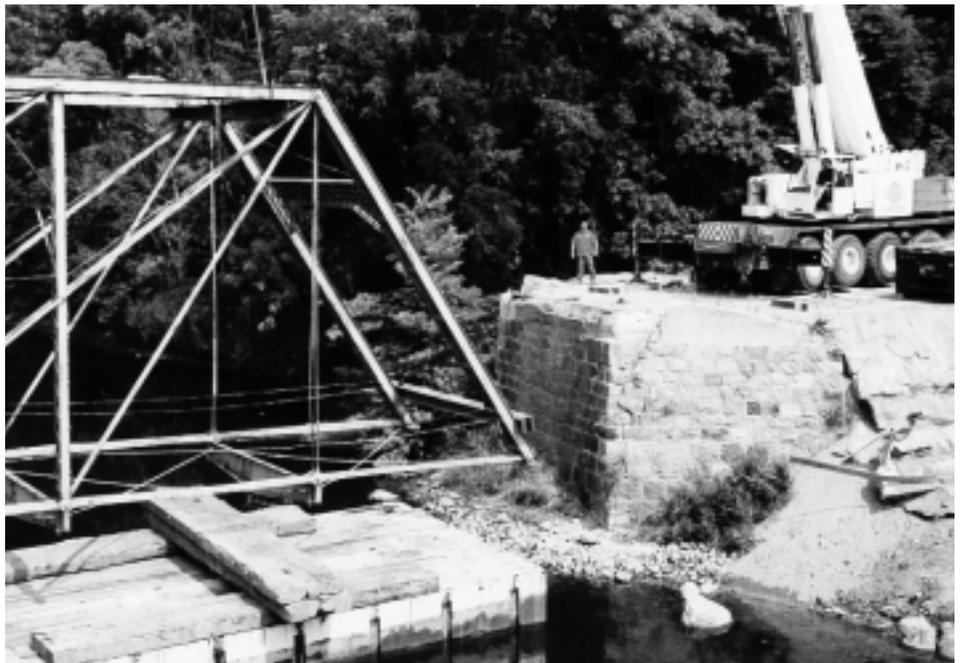
Figure 3. Lifting the Charlotte Highway bridge from its original abutment. This end was lowered onto a barge prior to hauling the bridge across the river and up the other bank.

Conventional analysis predicts that the lower chord of a single-span through truss is always in tension when the bridge is carrying gravity load. However, the lower chords in the end panels of the Charlotte Highway bridge were observed to be slack (i.e., subjected to compression rather than tension) when the bridge was in service in its original location. Those members remained slack after the vehicular railings and deck were removed in preparation for moving the

bridge from its masonry abutments. However, when the bridge was freed from its inoperative expansion bearings, that end appeared to move inland several inches and cracks opened where the wingwalls join the abutments. Apparently the upper chord and end posts had been functioning as an arch as well as restraining displacement of the heavy abutments and fill.

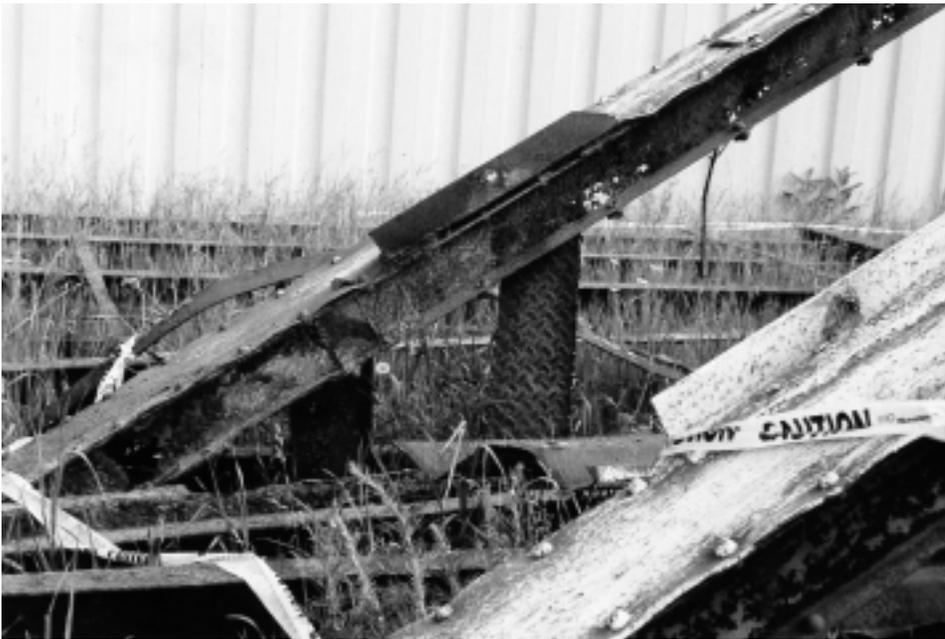
Figure 4. Severely corroded sections of the Twenty Mile Road bridge were replaced by welding new steel to sound original material.

The deck lateral ties of the Twenty Mile Road bridge were evaluated using the assumed strength of steel produced before 1905³ and found to be inadequate. The ties, like other parts of this bridge (Figure 4) were too badly corroded to be salvaged. Replacing them with new steel, in the original sizes, was sufficient to provide the required wind resistance.

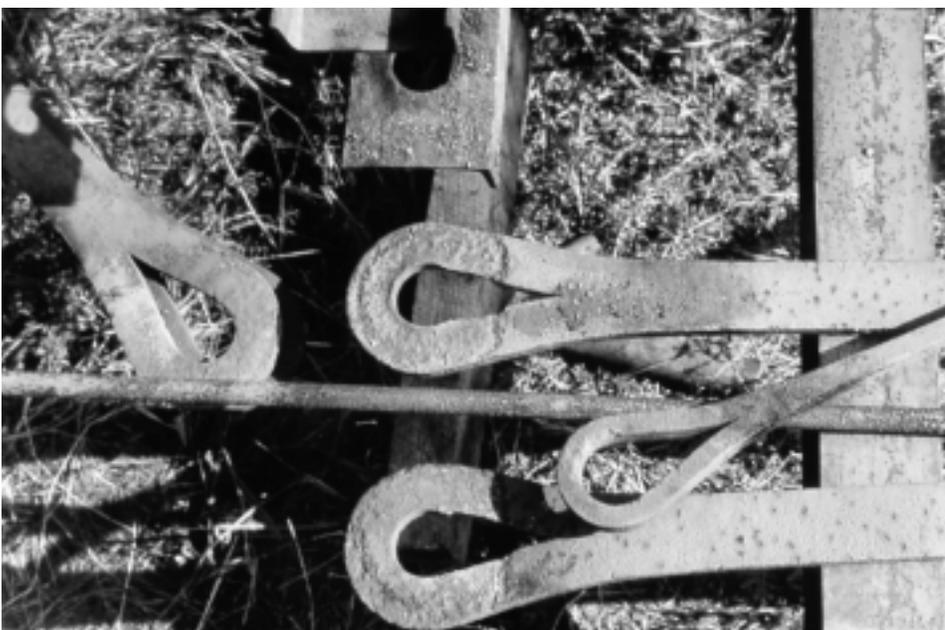
Figure 5. Forge-welded loop eyebars like these are obsolete.

Pony trusses and loop eyebars (Figure 5) are obsolete, and there are no current standards to guide assessment of these features. Pony trusses are prone to lateral instability of the top chords. That is, the bridge tends to fold inward under heavy load. The two rehabilitated pony trusses were checked for stability by Holt's method⁸ and both were found to have adequate factors of safety for pedestrian loading.

Ellerby et al⁶ demonstrated that fracture may occur at a forge weld rather than in the body of a bar, sometimes at a load significantly less than the design strength of the bar. As part of the same investigation, twenty-six wrought iron loop eyebars were repeatedly loaded to working stress level. The number of load cycles to failure suggests that the bars could have remained in highway service for many more decades. When fatigue fractures finally did occur, they were in the loops (except for two bars, which initially had large cracks at forge welds). The investigators speculated that repeated flexing of the loops was a critical factor and noted the deleterious effect of poor fit on the pin.

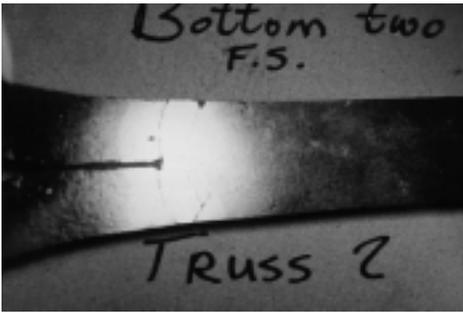
Figure 6. Dye penetrant inspection of a forge weld.

The usual practice for the project bridges is to inspect eyebar eyes and forge welds visually and by ultrasonic and dye penetrant methods (Figure 6). Cracks are ground out and bars are built back to original profile by arc welding. Testing has shown that careful arc welding restores full strength⁶.
