Chesaning Village, Parshallburg Bridge

The Chesaning Bridge, also know as the Parshallburg Bridge, was built by the Wrought Iron Bridge Co. of Canton, Ohio, in 1889 and moved to Chesaning, Michigan, in 1999. There it was painted, decked and set on new abutments with no alteration made to its original historic features. *The Secretary of the Interior's Standards for Rehabilitation* state that "deteriorated architectural features shall be repaired rather than replaced, wherever possible." These standards do not recommend "removing or radically changing architectural metal features which are important in defining the **overall historic character of the building so that, as a result, the character is diminished** (*emphasis mine*)." When the Chesaning Bridge is removed from the Shiawassee River and when future restoration begins, the original historic features and material will be preserved.

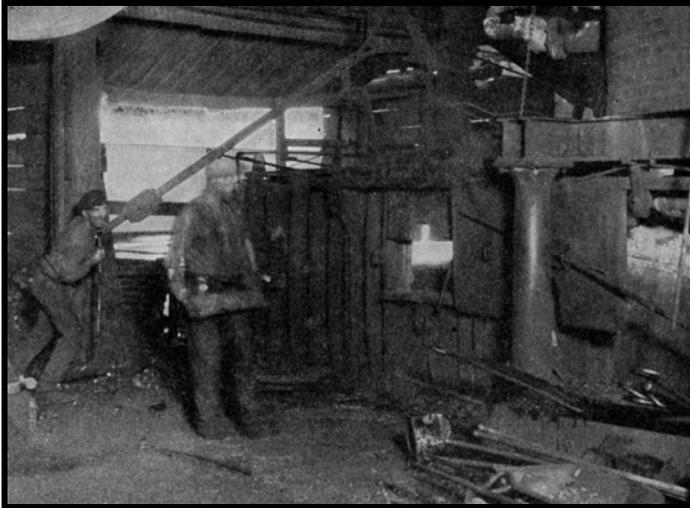
Charging the puddling furnace with pig iron

The bridge in Chesaning is made of a metal no longer produced, wrought iron, the product of the labor of an iron puddler. "When I became my father's helper he began teaching me to handle the machinery of the trade. The puddling furnace has a working door on a level with a man's stomach. the working door of a puddling furnace is the door through which the puddler does his work." (*The Iron Puddler*, James J. Davis, 1922)

Photos of the puddling furnace: *An Introduction to the Metallurgy of Iron and Steel*, H. M. Boylston, 1936

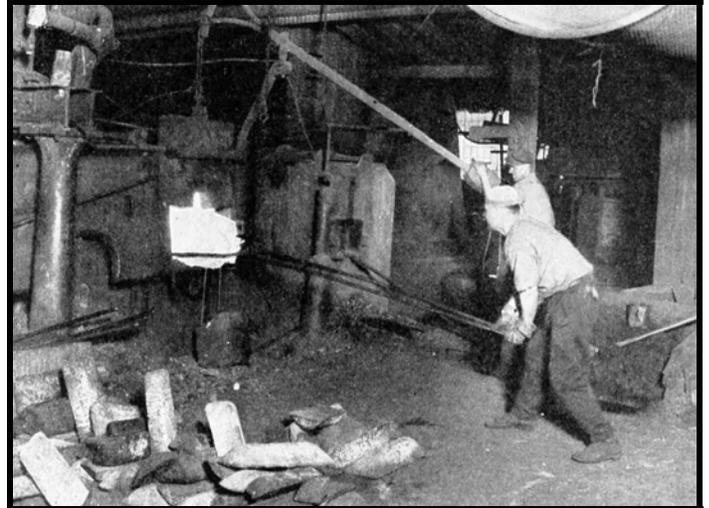
Removing wrought iron from the puddling furnace

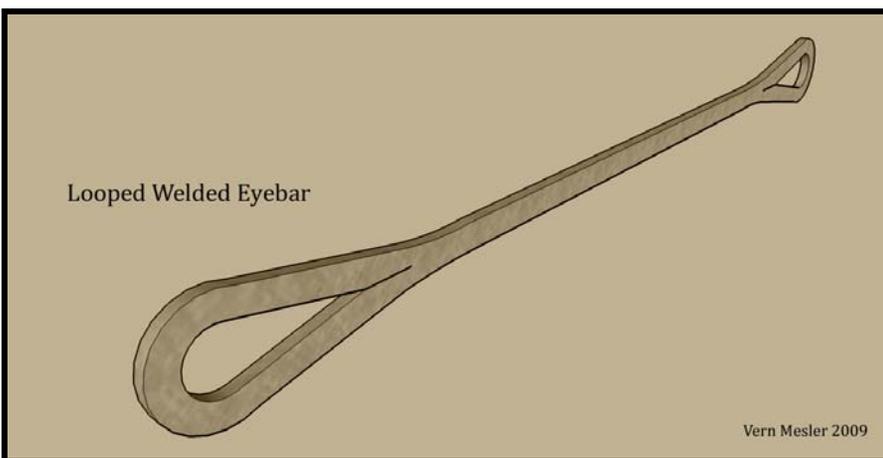
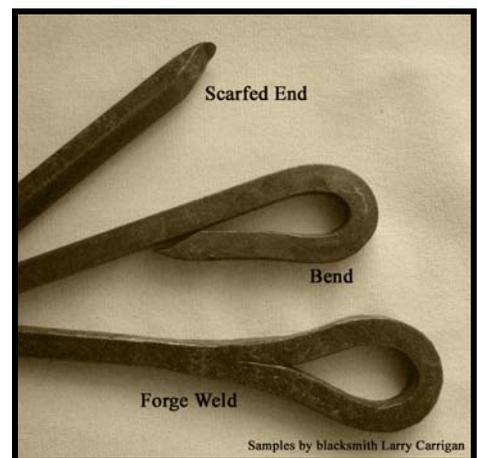
Many of the nineteenth century bridges were pin connected. One of the most significant members of a pin connected bridge is the eyebar, a tension member that was used as a diagonal and as a bottom chord. The Parshallburg Bridge is a pin connected Thacher truss with forge-welded looped wrought iron eyebars. The looped eyebar was made in the forge shop and required the most experienced craftsmen to make the forge weld.

The Parshallburg Bridge was fabricated in Canton, Ohio, at the Wrought Iron Bridge Co. with iron angles, channel, square bars and I-beams. The assemblies were riveted with wrought iron rivets; today the hot riveting process is rarely used in metal fabrication.
