Chesaning Village, Parshallburg Bridge

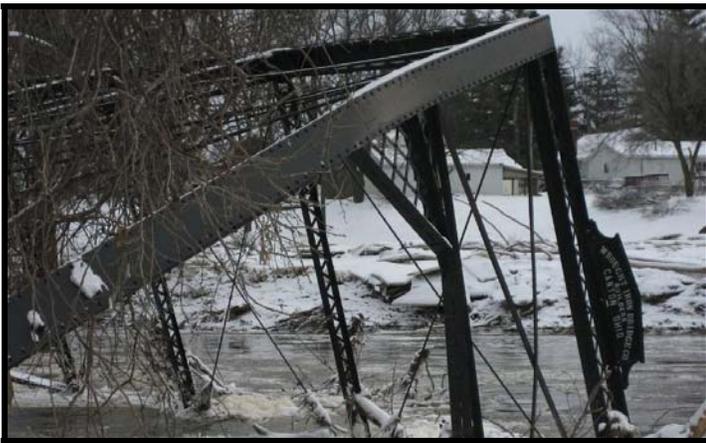
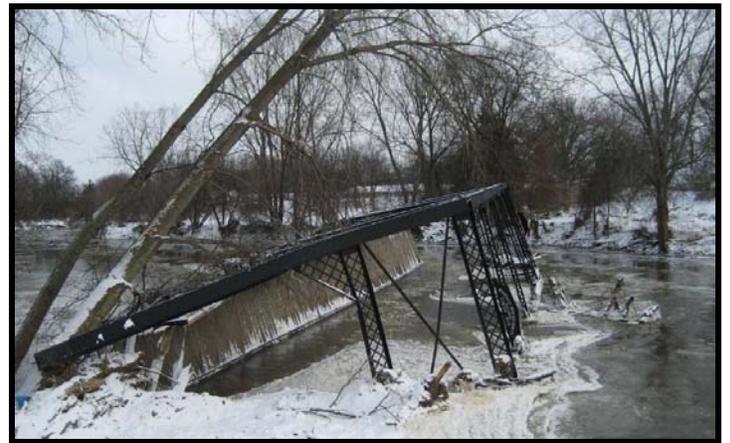
On December 28<sup>th</sup> 2008, the Shiawassee River in Chesaning, Michigan, was swollen and ice jammed. Its swift current piled ice and debris against the wrought iron bottom chord members of a restored historic metal truss bridge. As the river continued to rise, more ice and heavy debris piled along the length of the bridge and the relentless currents of the swollen Shiawassee River weakened the resistance of the anchor bolts that held the bridge in place and ripped them from the abutments. The historic bridge began drifting atop the swift river and one of the heavy wrought iron inclined end posts caught and wedged against trees along the shore. The bridge slowly rolled on its side.

The wrought iron bridge that lay on its side, its bent inclined end post anchored to a tree, is the Parshallburg Bridge built by the Wrought Iron Bridge Co. of Canton, Ohio, 1889.

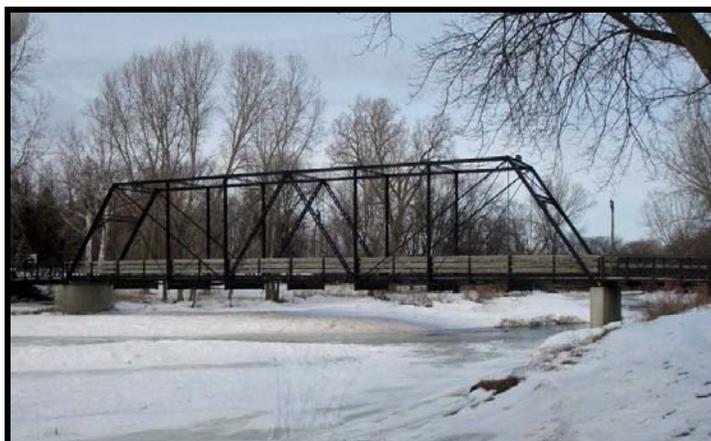
*Parshallburg Bridge, Chesaning Village, winter 2007*

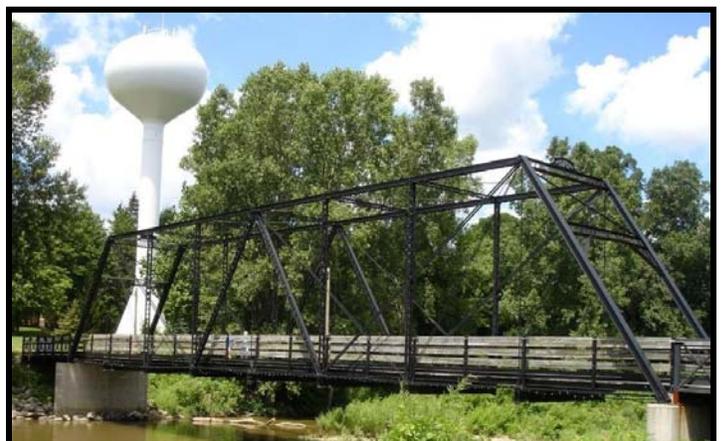
*Parshallburg Bridge, Chesaning Village, summer 2006*

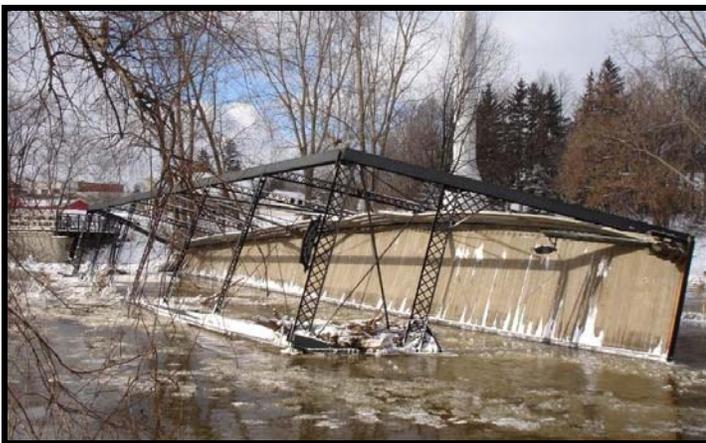
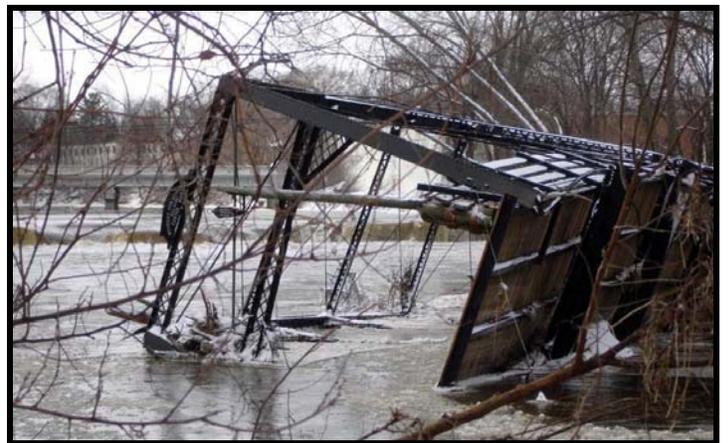
Scott Davis from McNally & Nimergood (a crane company with experience handling difficult and seemingly impossible jobs) closely inspected the bridge. With the eye of a professional rigger, he began visualizing the size and location of cranes and along with Latsch began to explore rigging methods that could be used to remove the bridge from the river. Neil Pullman (engineer retired from the Bay Region MDOT bridge program)
