In visiting the Village of Chesaning today, I was not expecting the additional damage I saw on the bridge, and it was very disappointing to see. I've spent a lot of time and effort over the years trying to save historic metal truss bridges and it was difficult to view this damaged historic bridge, a bridge that had been restored and had more than ninety percent of the original material still remaining.

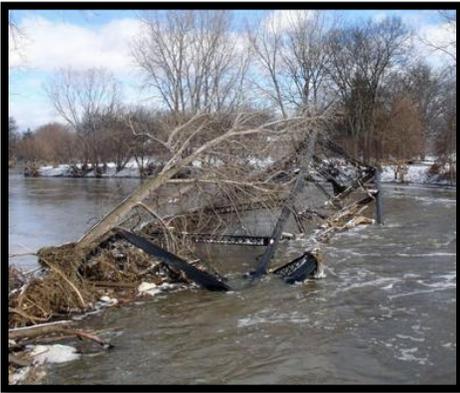
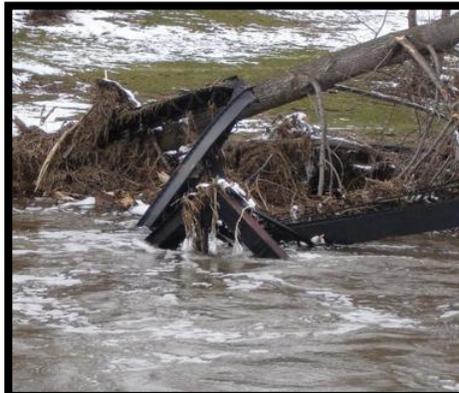
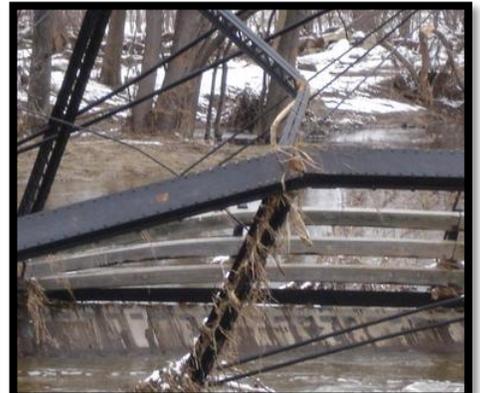
At this time, I do not believe the bridge can be removed from the river with cranes and set up for restoration. Several sections of the top chord have separated at the splice joints and some splice plates appear to be broken. The west end inclined end post that is visible is severely twisted and the portal is bent and possibly separated from the inclined end posts. The verticals, diagonals, and bottom chord eyebars that are not visible may be bent and separated from the pin connections. Although the historic sections of the bridge have been seriously damaged, in my opinion the historic wrought iron members can be restored and the bridge eventually reassembled, but the time and cost will be difficult to determine and may not be within the time frame or cost acceptable to the Village of Chesaning.

The bridge is made up of historic wrought iron, modern steel, and wood. The steel and wood make up about a third of the bridge material and are not original. When the bridge is removed from the river I would recommend that the steel and wood be removed and scrapped. However, I recommend that the historic wrought iron members be removed and saved, stored in a secure location either in Chesaning or another location for future restoration. By preserving the historic material of the Parshallburg Bridge it would be noted that the Village of Chesaning has made a good faith effort to save this rare historic metal truss bridge and the monies invested in the original restoration of the bridge.
